**ALBION-SHERIDAN TOWNSHIP LANDFILL
REMOVAL ACTION PLAN
ALBION, MICHIGAN**

**WESTON - MAJOR PROGRAMS
Technical Assistance Team
Region V**

January 1990

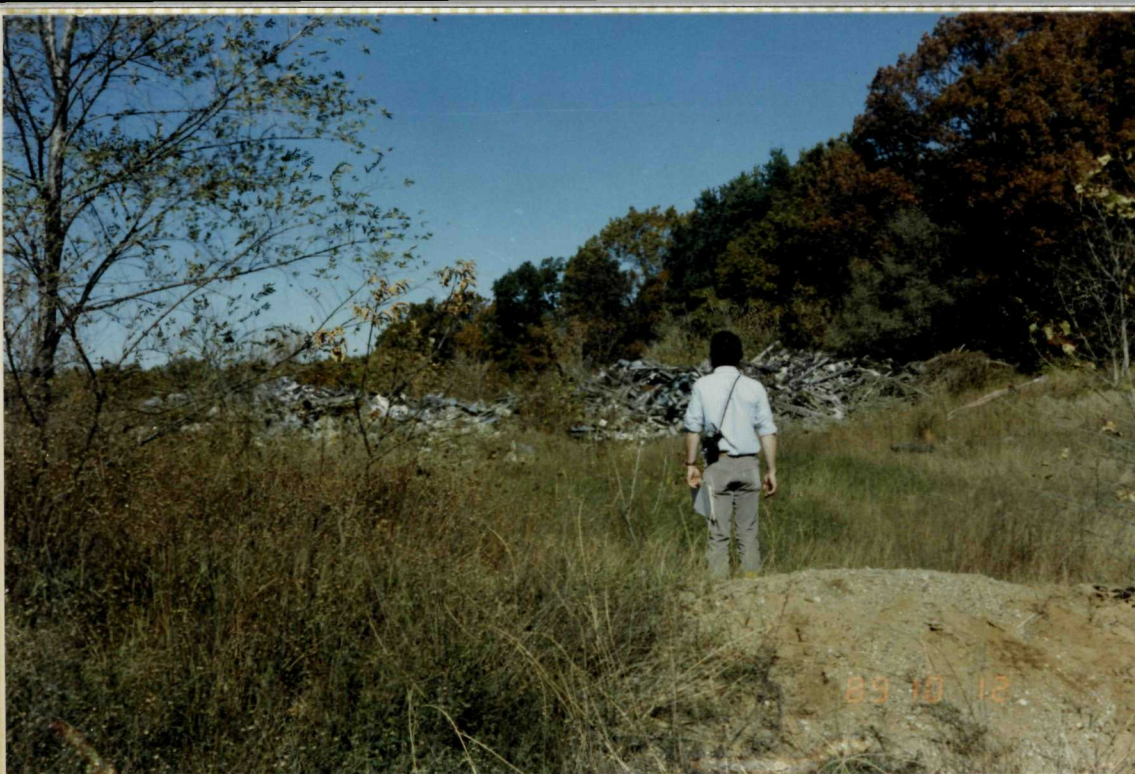
ROLL 1 PHOTO 0

View of demolition debris along the northeast perimeter of landfill. Area being viewed by field investigator from Center for Environmental Health Sciences - Michigan Department of Public Health.

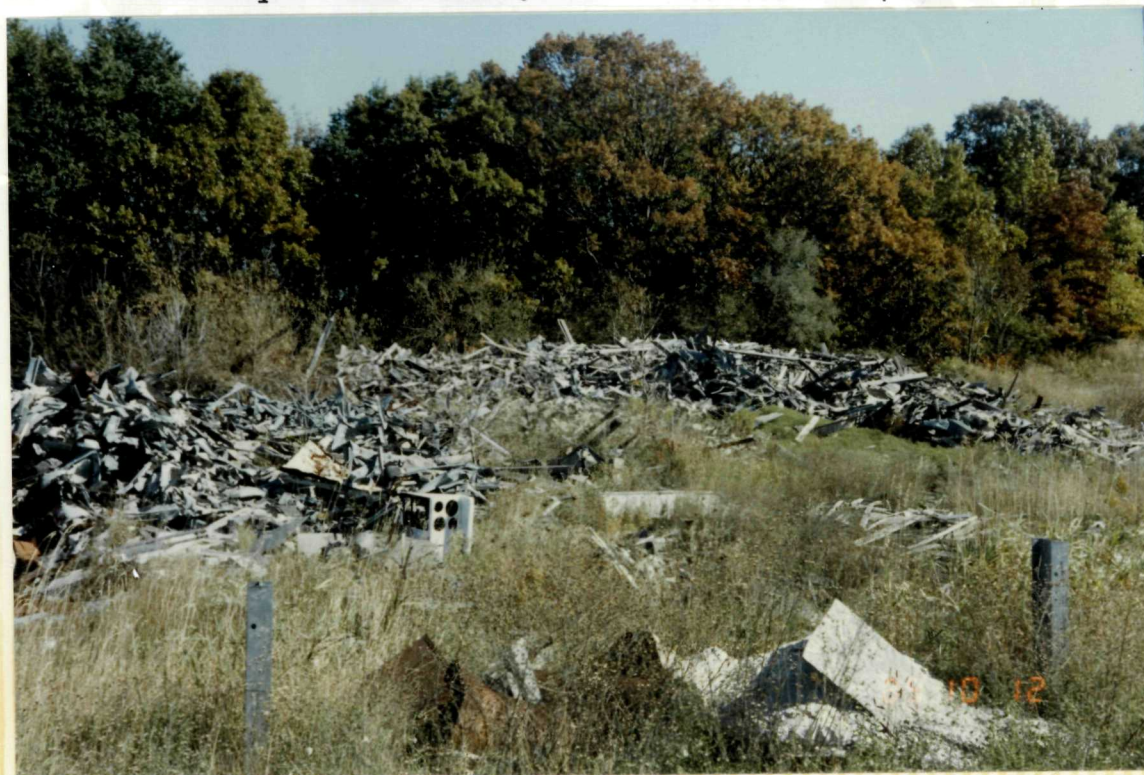
ROLL 1 PHOTO 1

View of demolition debris along northeast edge of of landfill. Majority of debris consisted of discarded appliances and building rubble.

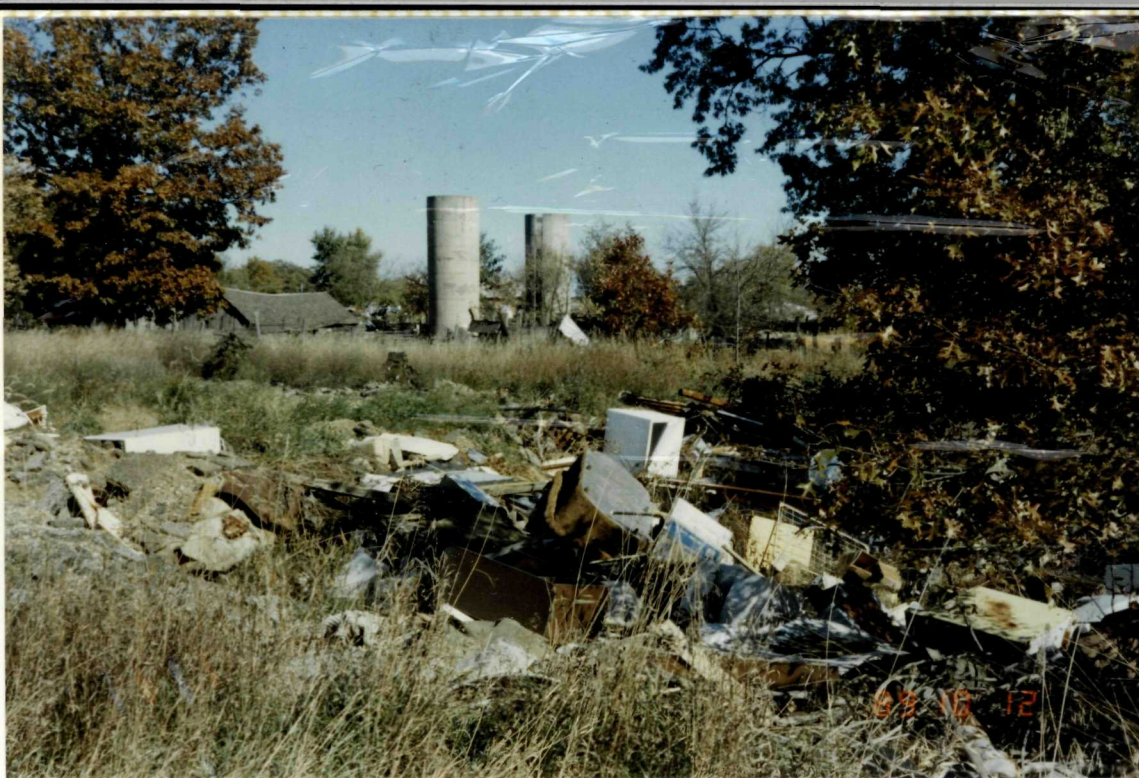
ROLL 1 PHOTO 2
 Albion-Sheridan Township Landfill
 Albion, Michigan
 View of demolition debris that had been placed
 along the northeast edge of the landfill. Farm
 and swine operation located in photo
 background.
 Photo by J. Boeckman *JB* October 12, 1989

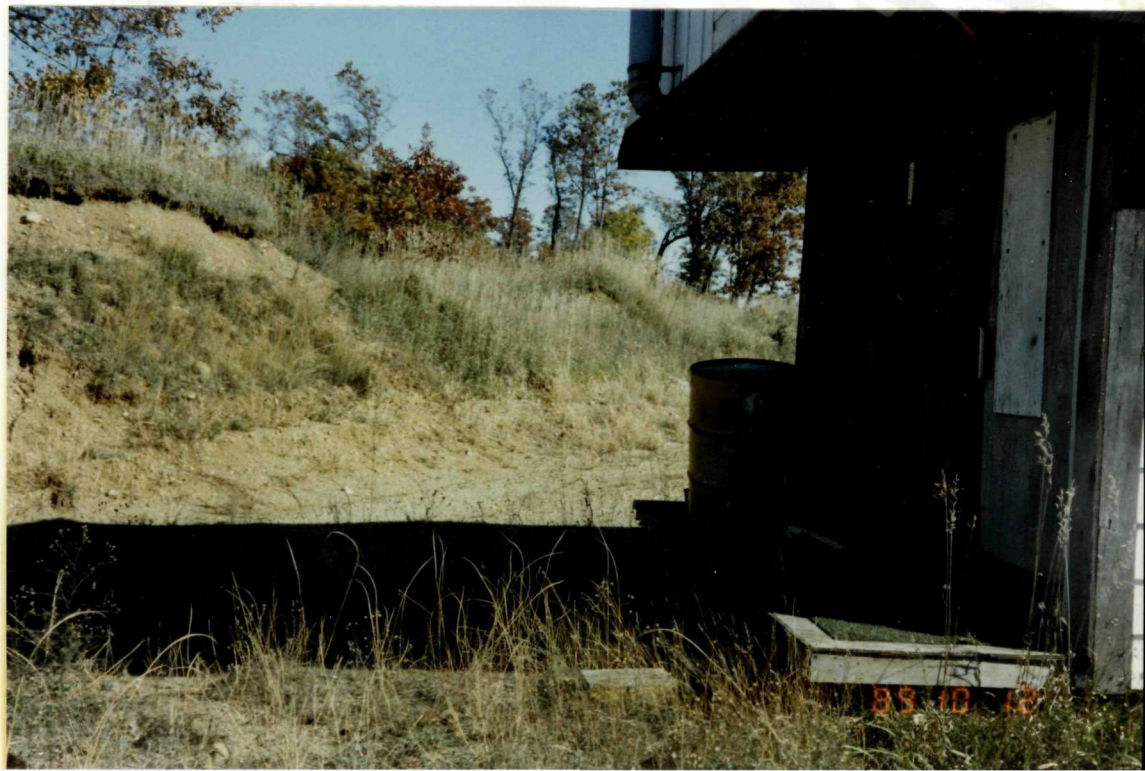
ROLL 1 PHOTO 3
 Albion-Sheridan Township Landfill
 Albion, Michigan
 View of storage shed located along southern
 entrance to the landfill. The 55-gallon drum
 contained approximately ten gallons of unused
 motor oil. Locked shed held an unknown number
 of 55-gallon drums; drum contents were unknown.
 Photo by K. M. Hanlon *KMH* October 12, 1989

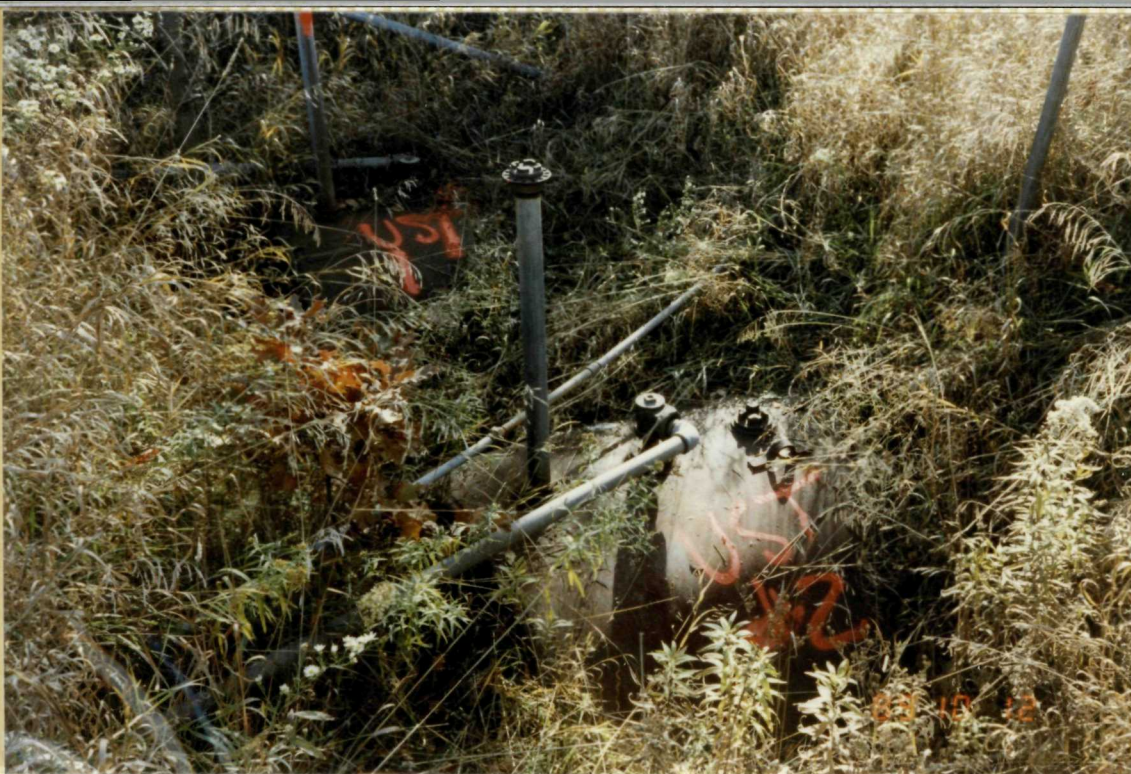
Two of the storage tanks observed were partially buried and connected to inoperable gasoline pumps; the storage capacity of each tank was estimated to be approximately 500 gallons. The first tank was empty, and because the second tank was locked, the type and quantity of any contents could not be determined. The third storage tank, which was positioned horizontally on the landfill surface, was empty, and its storage capacity was estimated to be 8,000 gallons. The exterior surface of most of the twenty-seven 55-gallon drums were rusted; eleven were empty and sixteen were full or partially full of material. Four of the five small metal containers held some amount of material; two contained unused industrial grease. Concurrent with the container inventory, the TAT conducted air monitoring with an HNu photoionization detector (HNu) equipped with an 11.7 eV probe. Only two readings were observed above the background level: inside drum B-4 (25 units) and at the opening of one of the two partially buried tanks (17 units).

ROLL 1 PHOTO 4
 Albion-Sheridan Township Landfill
 Albion, Michigan
 View of two partially buried gasoline storage tanks. Tank capacity was approximately 500 gallons each. Tank #1 was empty; all openings to tank #2 were either locked or rusted shut and prevented further investigation.
 Photo by K. M. Hanlon *KMH* October 12, 1989

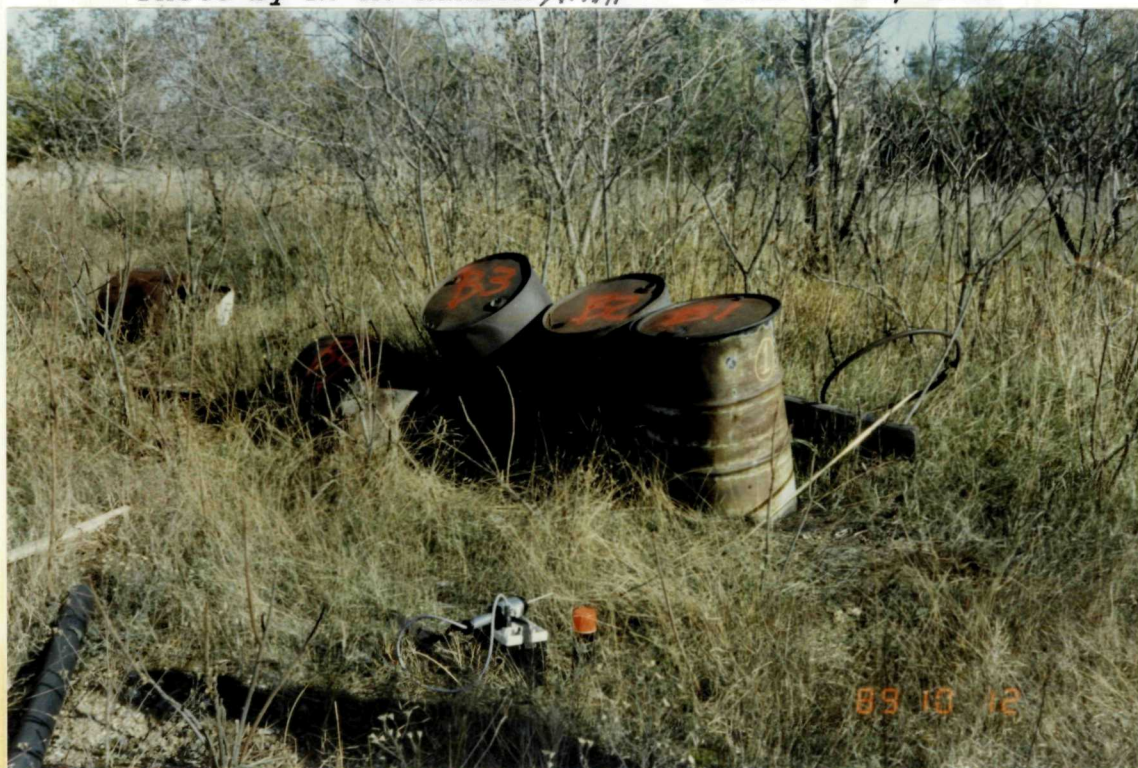
ROLL 1 PHOTO 5
 Albion-Sheridan Township Landfill
 Albion, Michigan
 View of abandoned 55-gallon drums near the center of the landfill. The contents of the drum labeled B4 were sampled and analyzed; the material was a RCRA F-listed waste.
 Photo by K. M. Hanlon *KMH* October 12, 1989

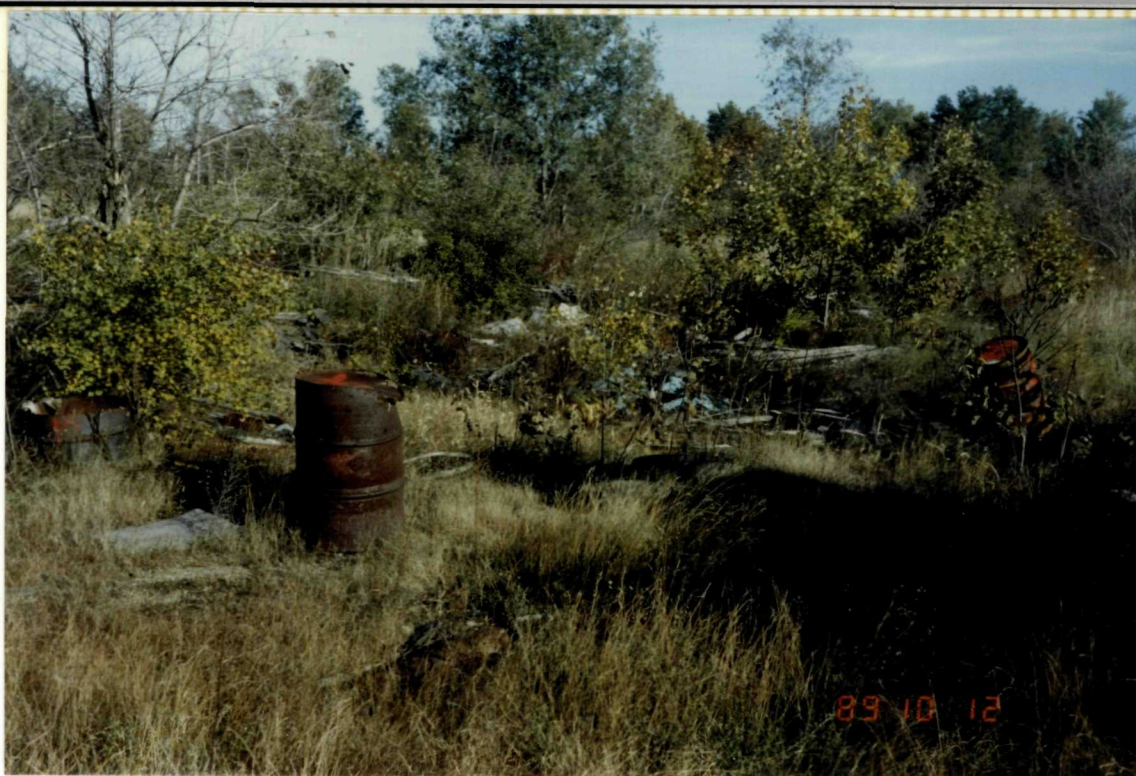
ROLL 1 PHOTO 6

View of empty, rusted drums scattered on the surface of the landfill. Near the drums were the charred remains of what appeared to be a small wooden structure.

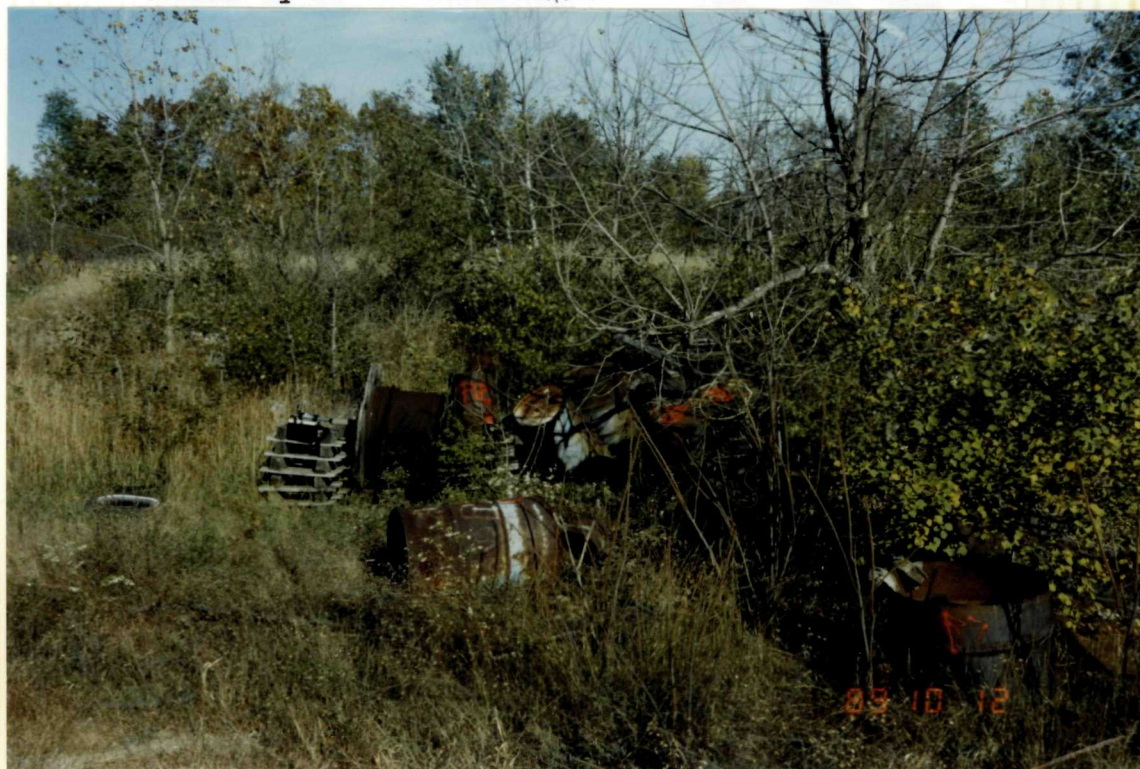
ROLL 1 PHOTO 7

View of abandoned drums at the landfill. A total of twenty-seven 55-gallon drums were found on the surface of the landfill; only sixteen of the total contained any material.

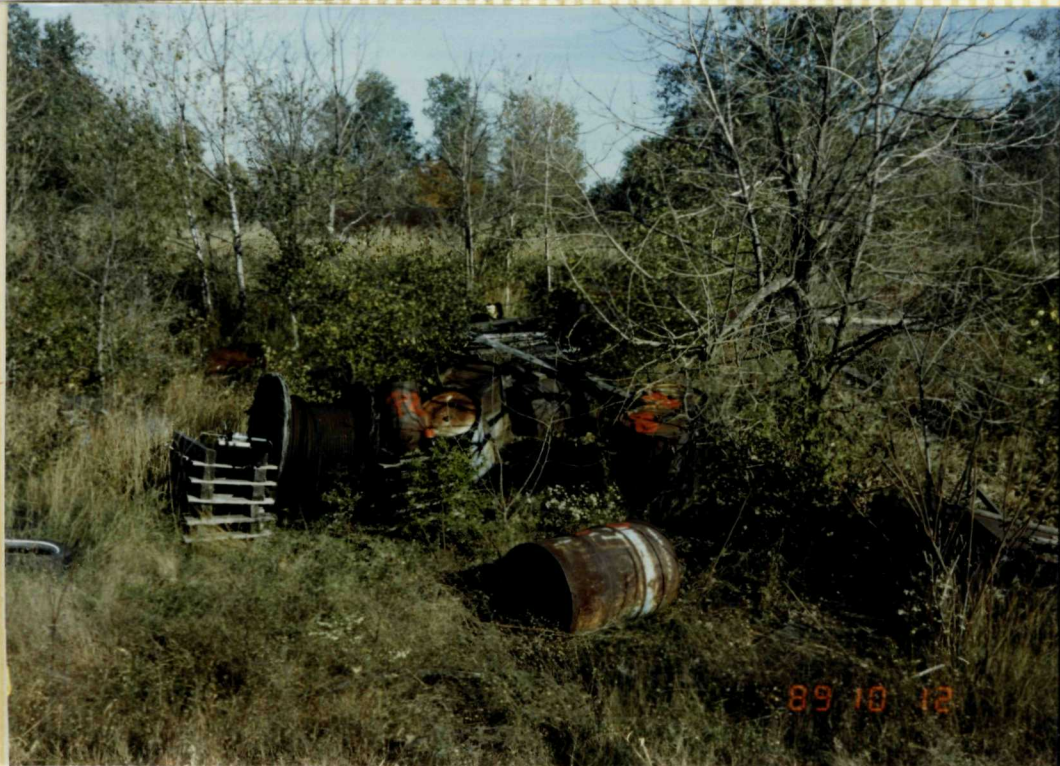
ROLL 1 PHOTO 8
 Albion-Sheridan Township Landfill
 Albion, Michigan
 View of abandoned drums at the landfill. Note
 the large above-ground storage tank in the
 photo background.
 Photo by K. M. Hanlon *KMH* October 12, 1989

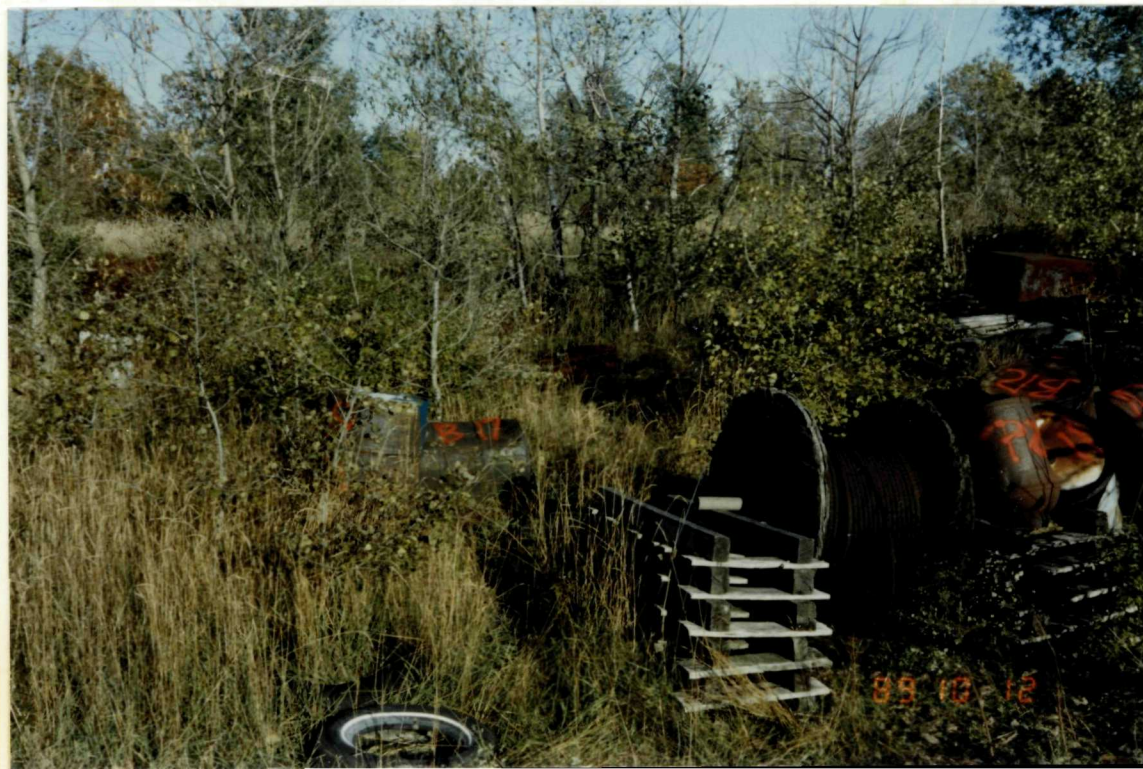
ROLL 1 PHOTO 9
 Albion-Sheridan Township Landfill
 Albion, Michigan
 View of abandoned drums and other debris found
 on the surface of the landfill.
 Photo by K. M. Hanlon *KMH* October 12, 1989

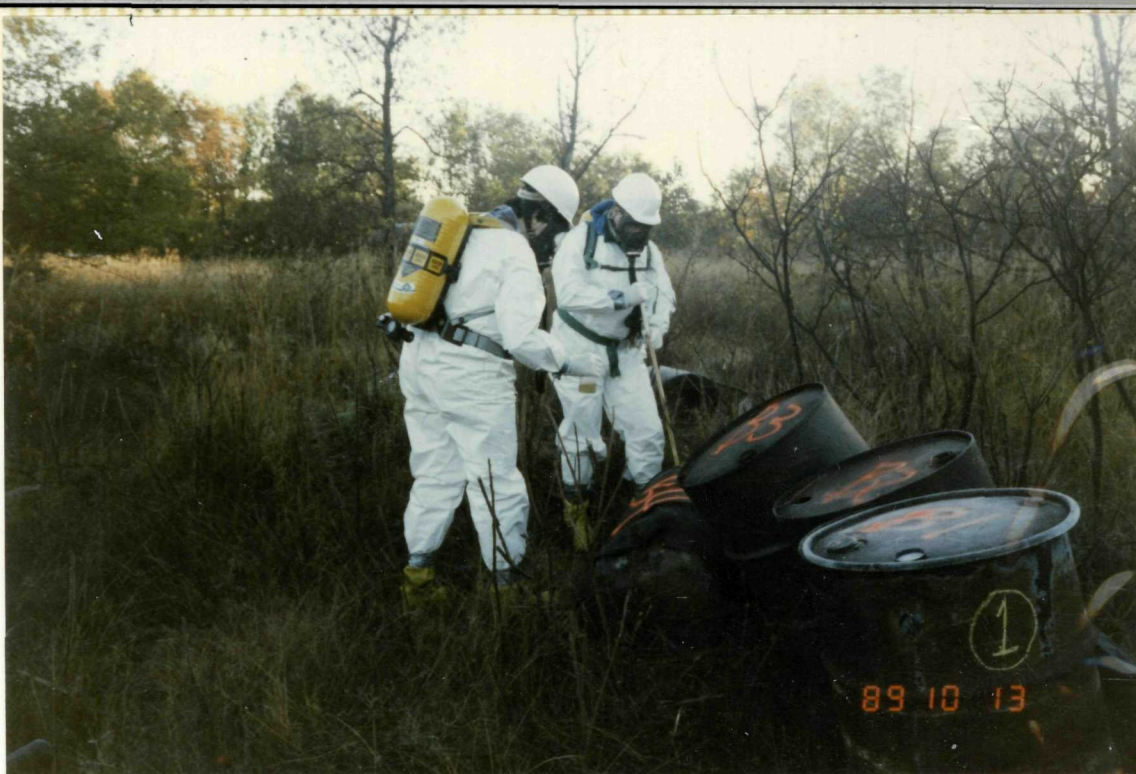
ROLL 1 PHOTO 10
 Albion-Sheridan Township Landfill
 Albion, Michigan
 TAT members Weed and Hanlon collecting a sample
 of liquid from drum B4 at the landfill. A drum
 thief was used to collect a 16 oz. sample from
 the drum.
 Photo by J. Boeckman JB October 13, 1989

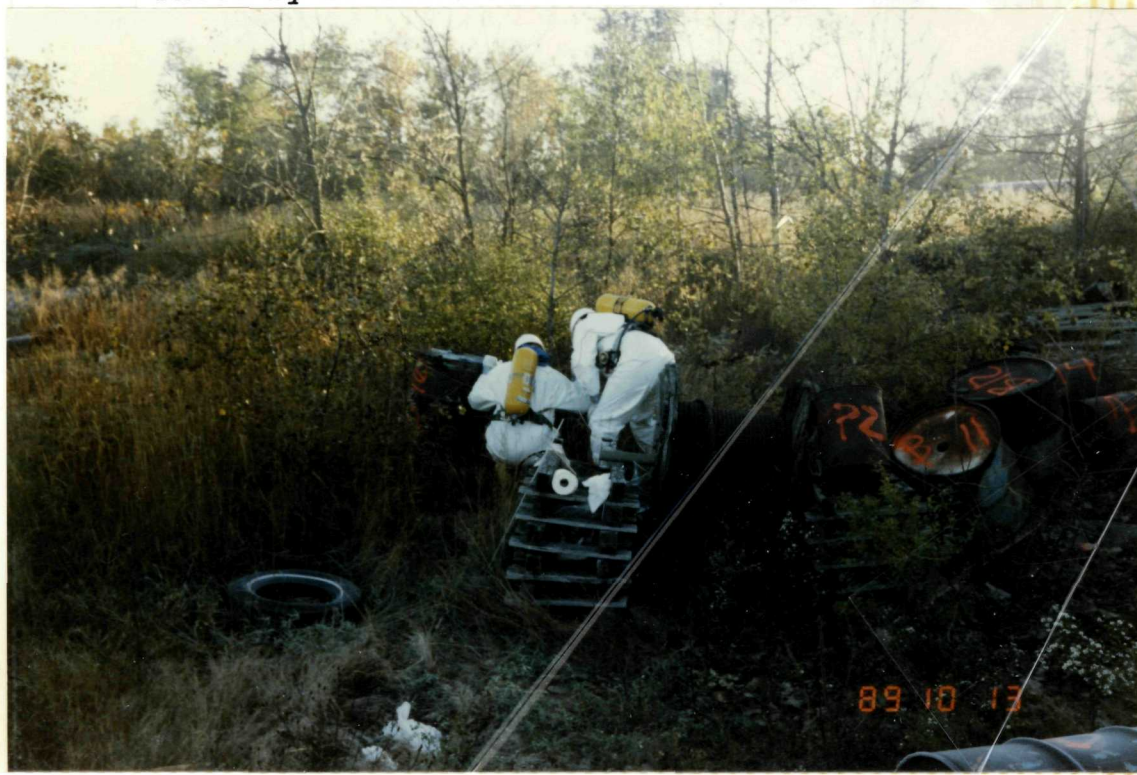
ROLL 1 PHOTO 11
 Albion-Sheridan Township Landfill
 Albion, Michigan
 TAT members Weed and Hanlon collecting samples
 from drums B16 and B17. Both drums contained
 material which exhibited the characteristic of
 ignitability.
 Photo by J. Boeckman JB October 13, 1989
